10 YEARS long term follow-up of Neobiotech IS-II Active #5

Director of Global Academy of Osseointegration

Dr. Young-ku Heo

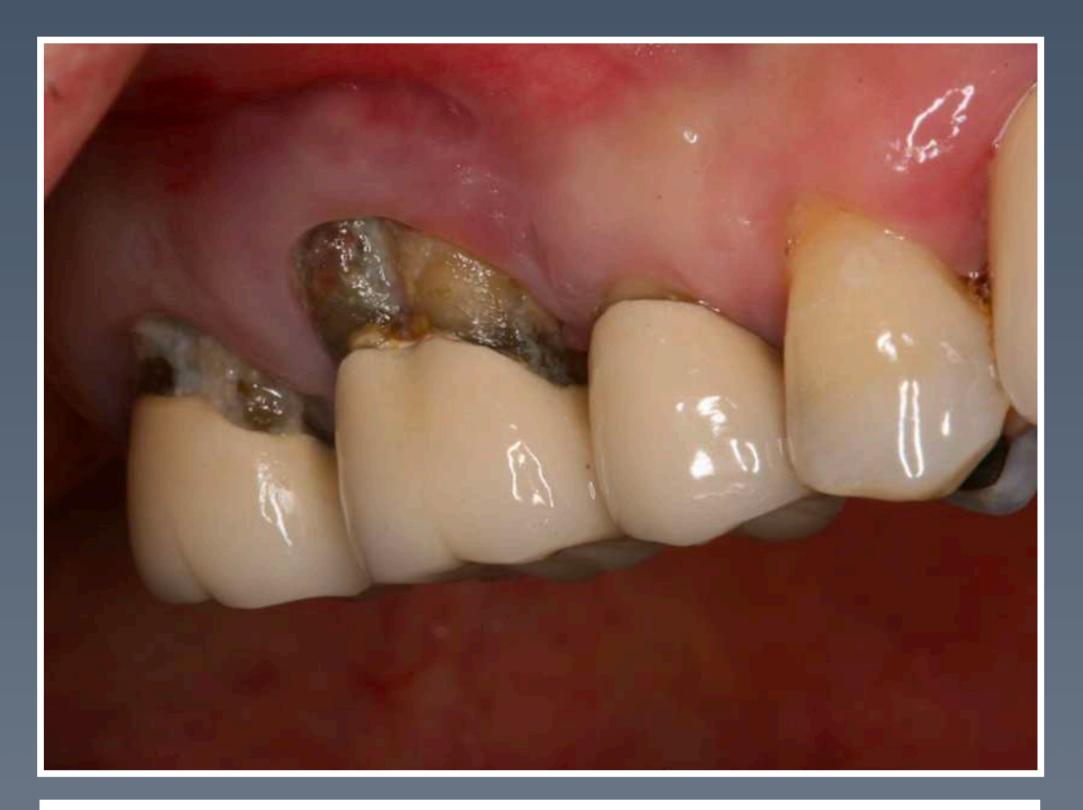
Intraoral picture before surgery

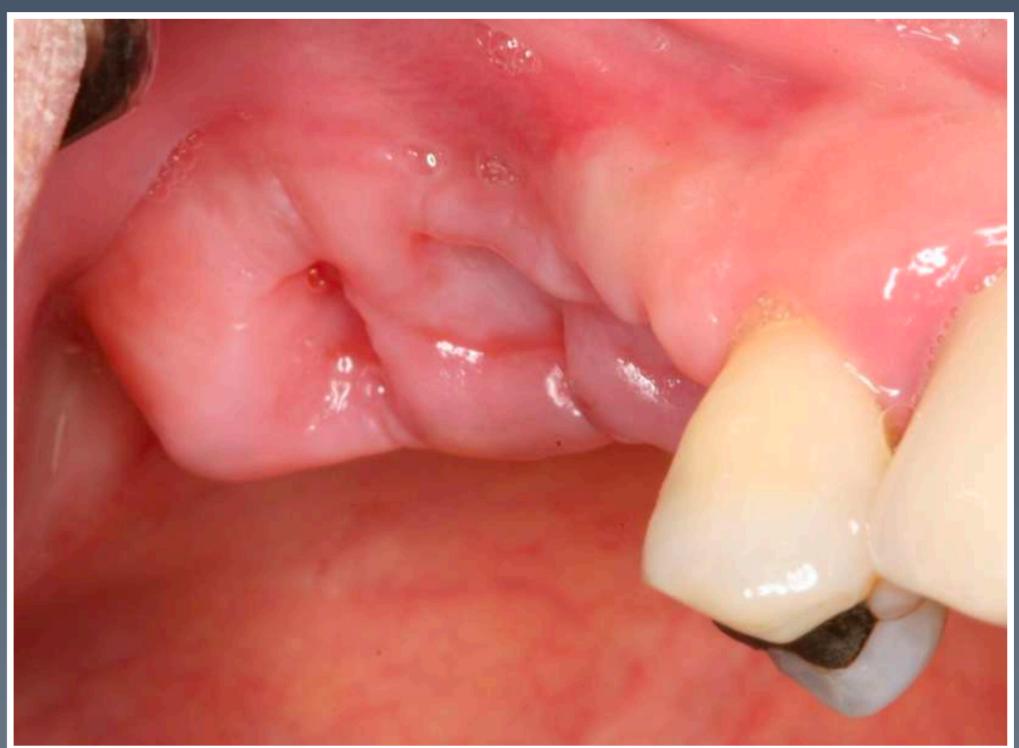
Intraoral view of the site after extraction. Horizontal defect on the buccal side was observed.

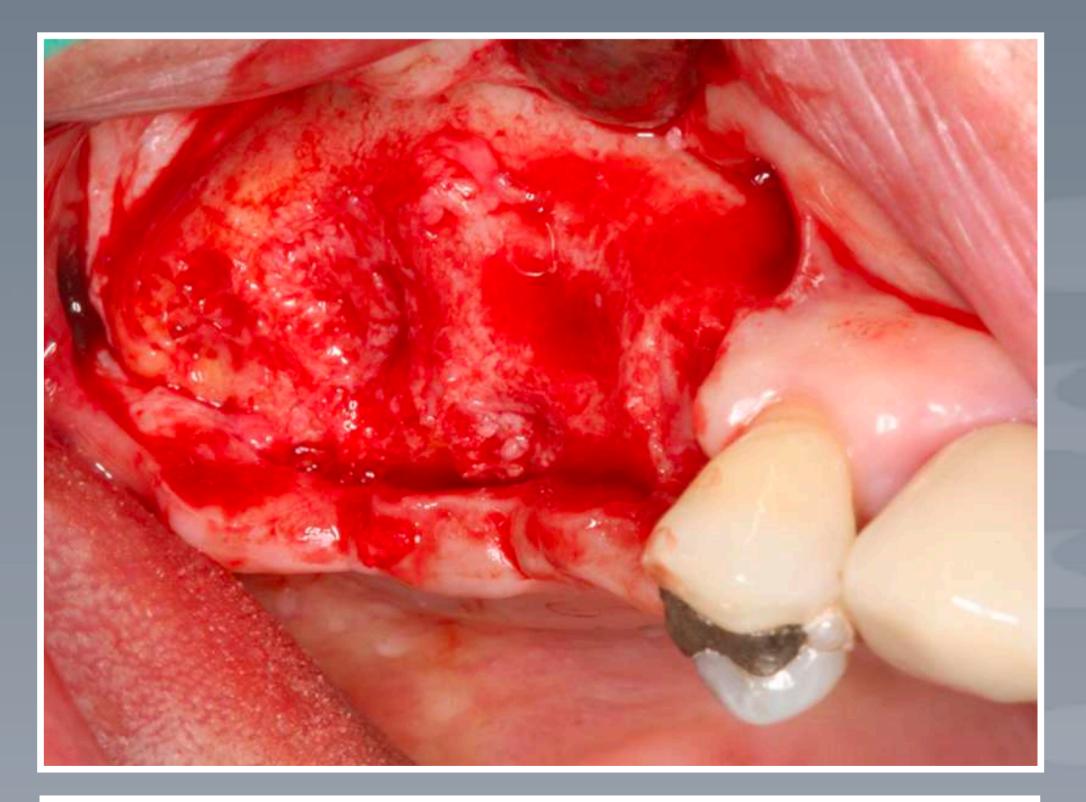
Access was gained via full thickness flap with crestal and vertical incision.

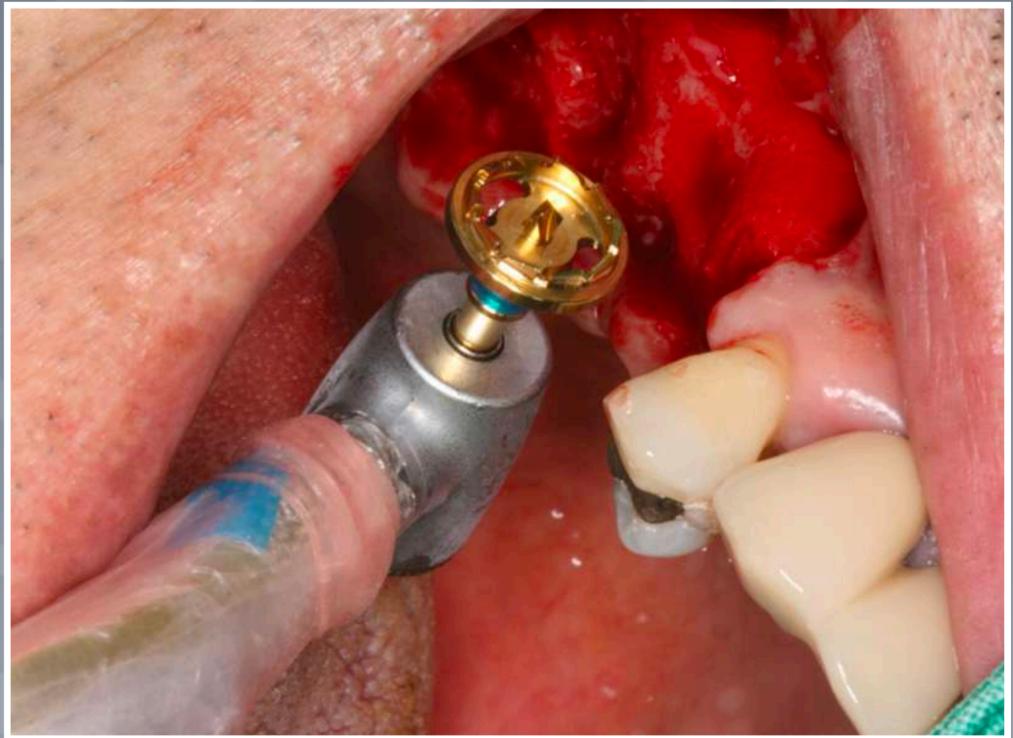
The LS-reamer was used to make a lateral hole. The reamer should be tilted side to side for depth control.

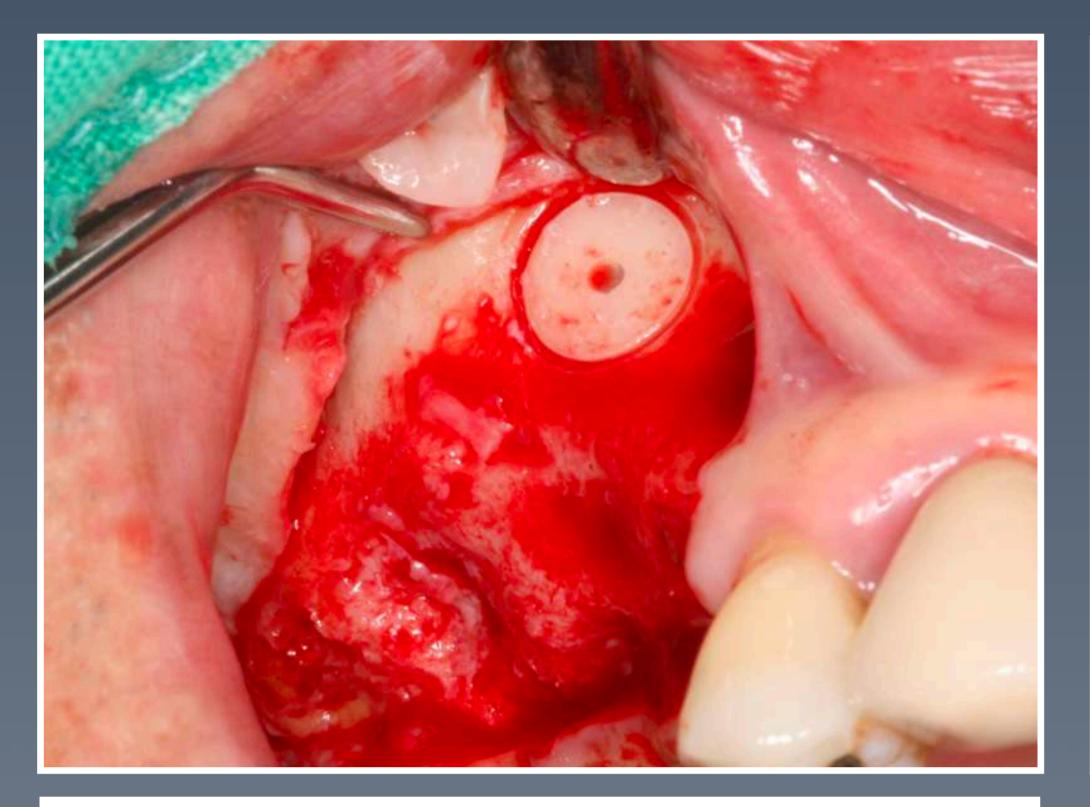
A lateral window was made with LS-reamer.

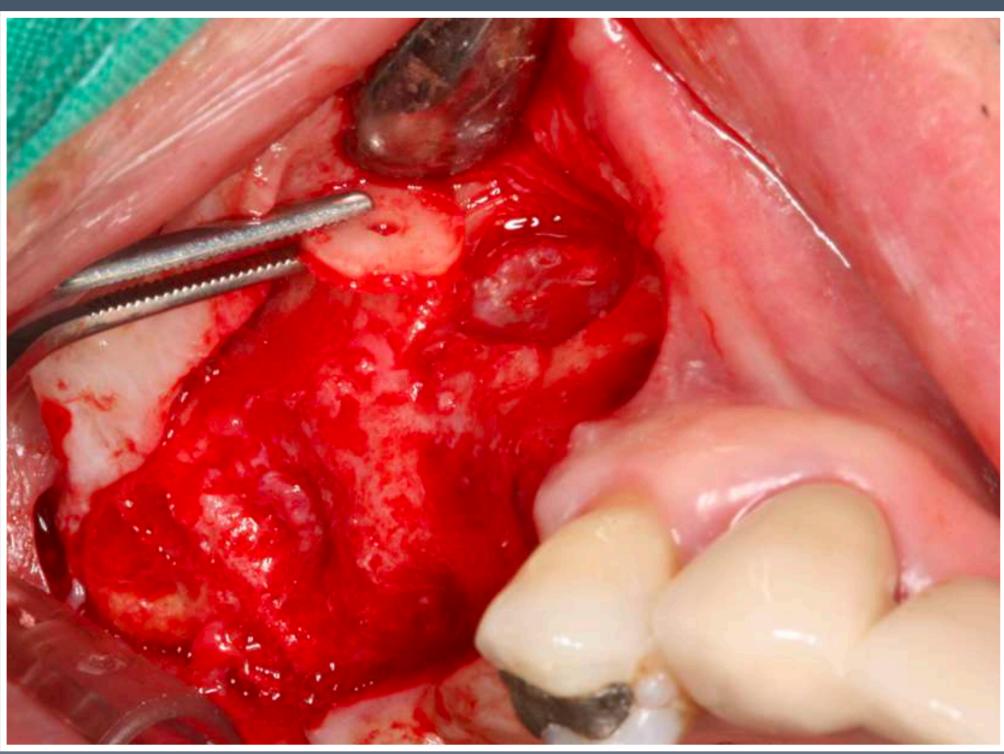
Lateral bone core was detached.

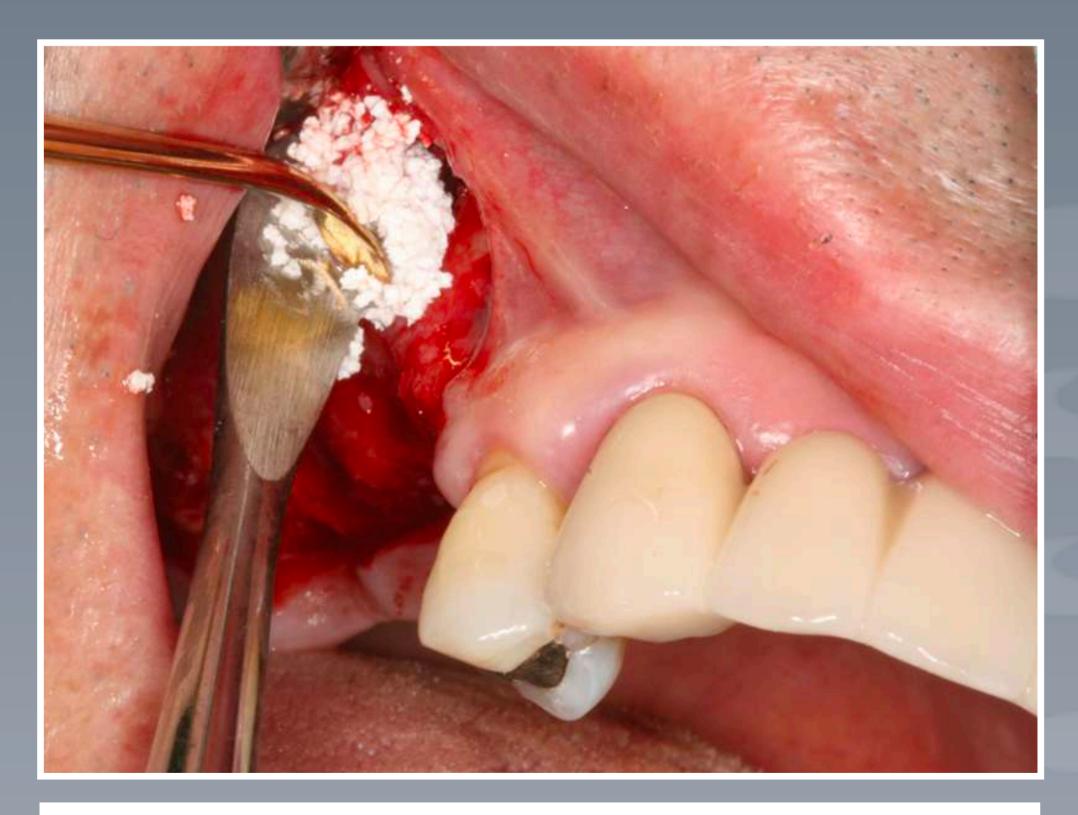
Bone graft material(Calpore; synthetic bone) was inserted.

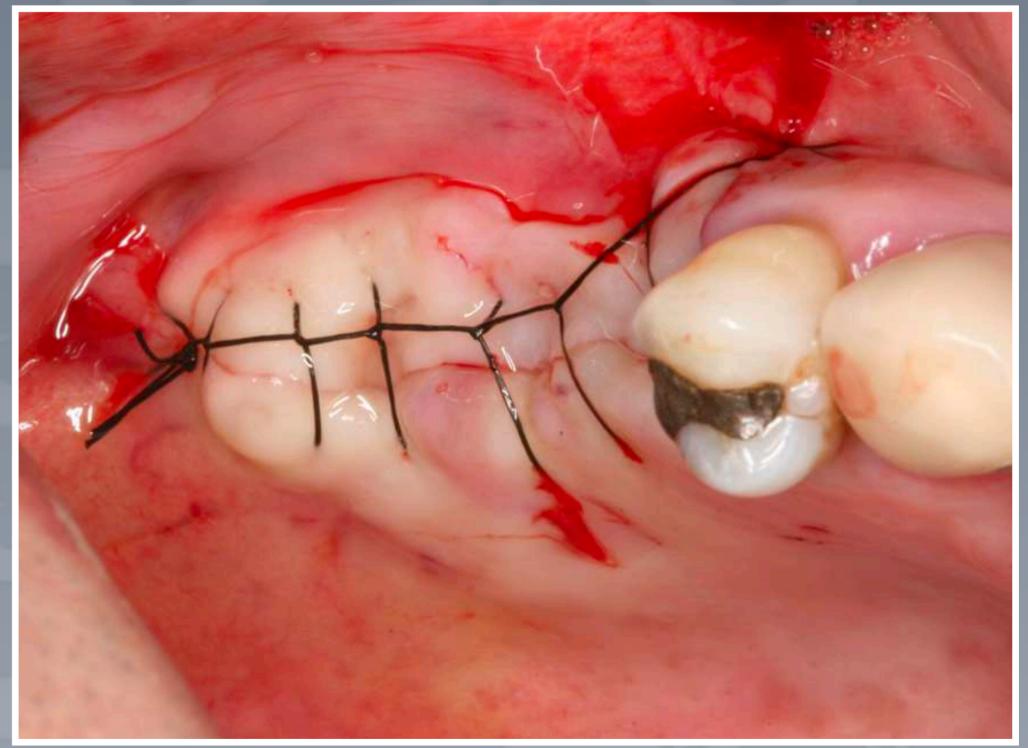
Continuous suture was made.

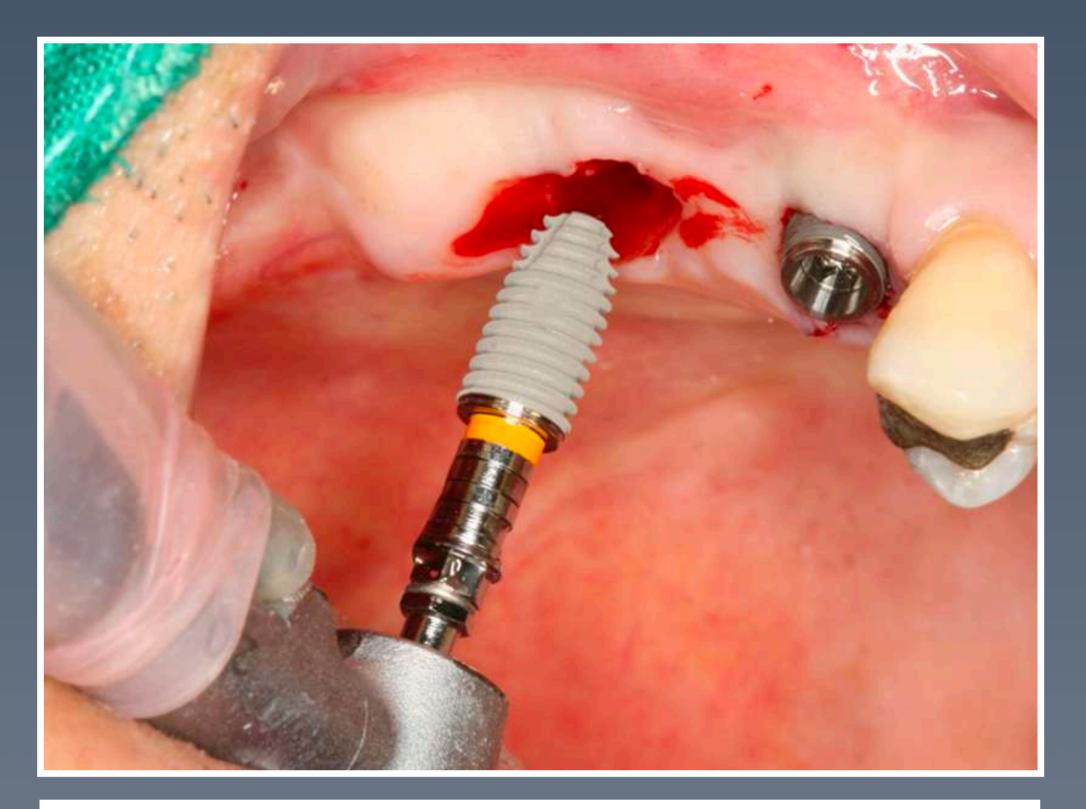
IS-II Active fixtures were placed.

#15: IS-II Ø4.5 X 10mm #17: IS-II Ø5.0 X 10mm

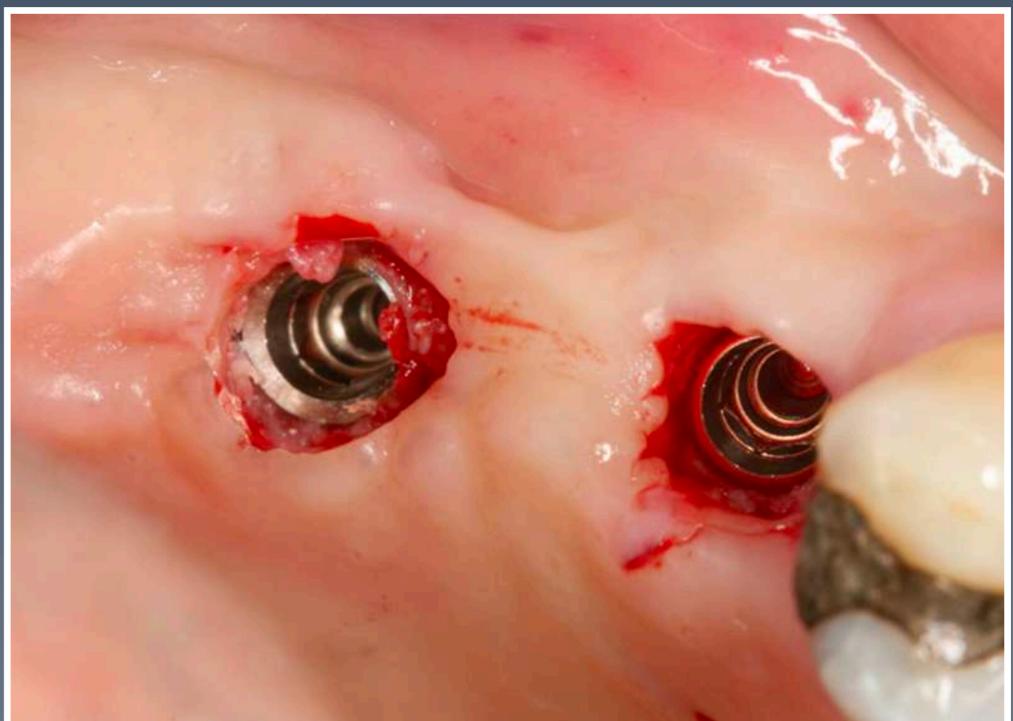
Both implants were placed in ideal position.

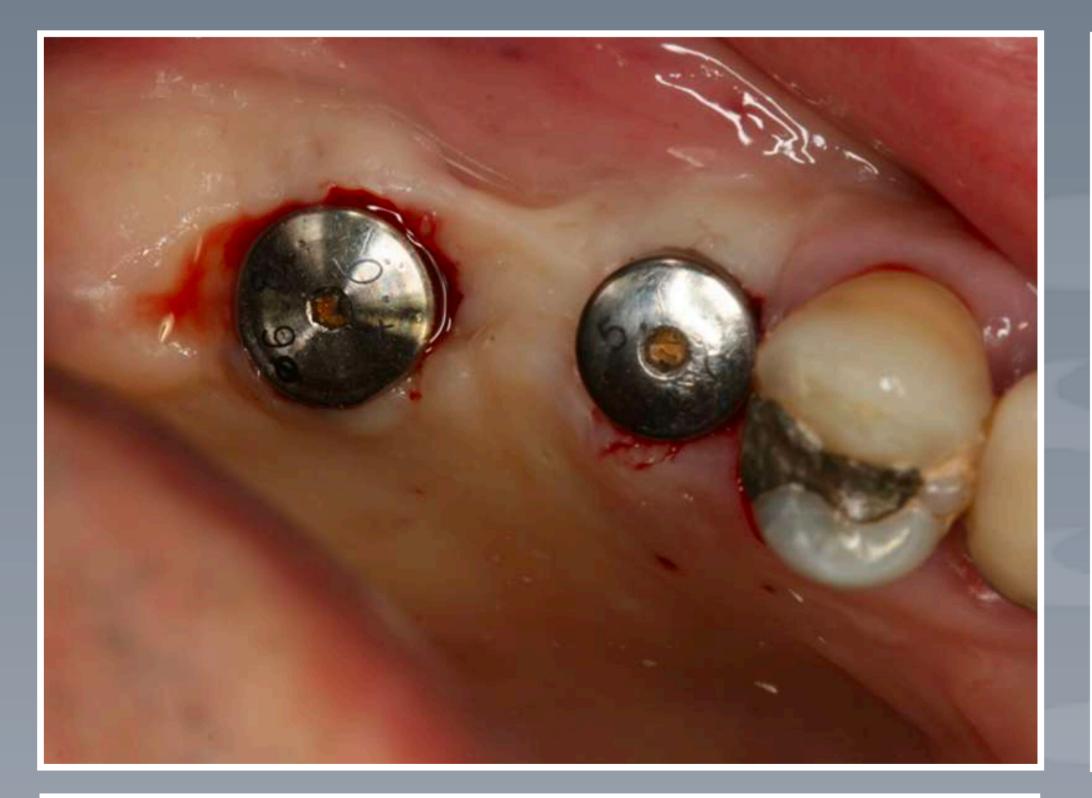
Healing abutments were connected. There were enough attachment gingiva around the healing abutments.

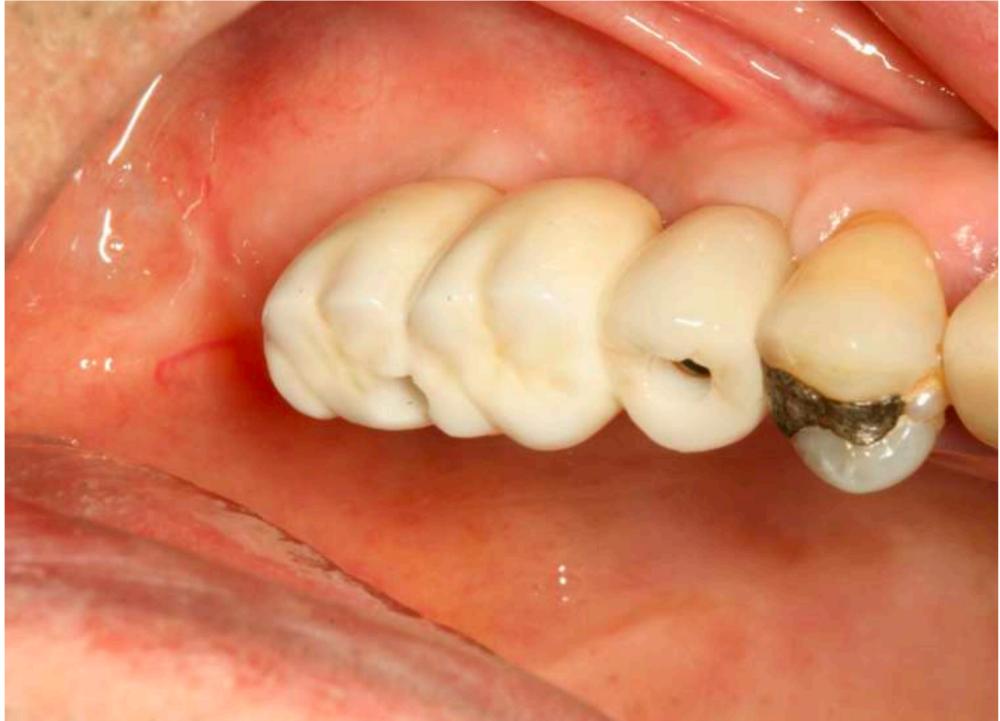
Buccal view after delivery of the prosthesis.

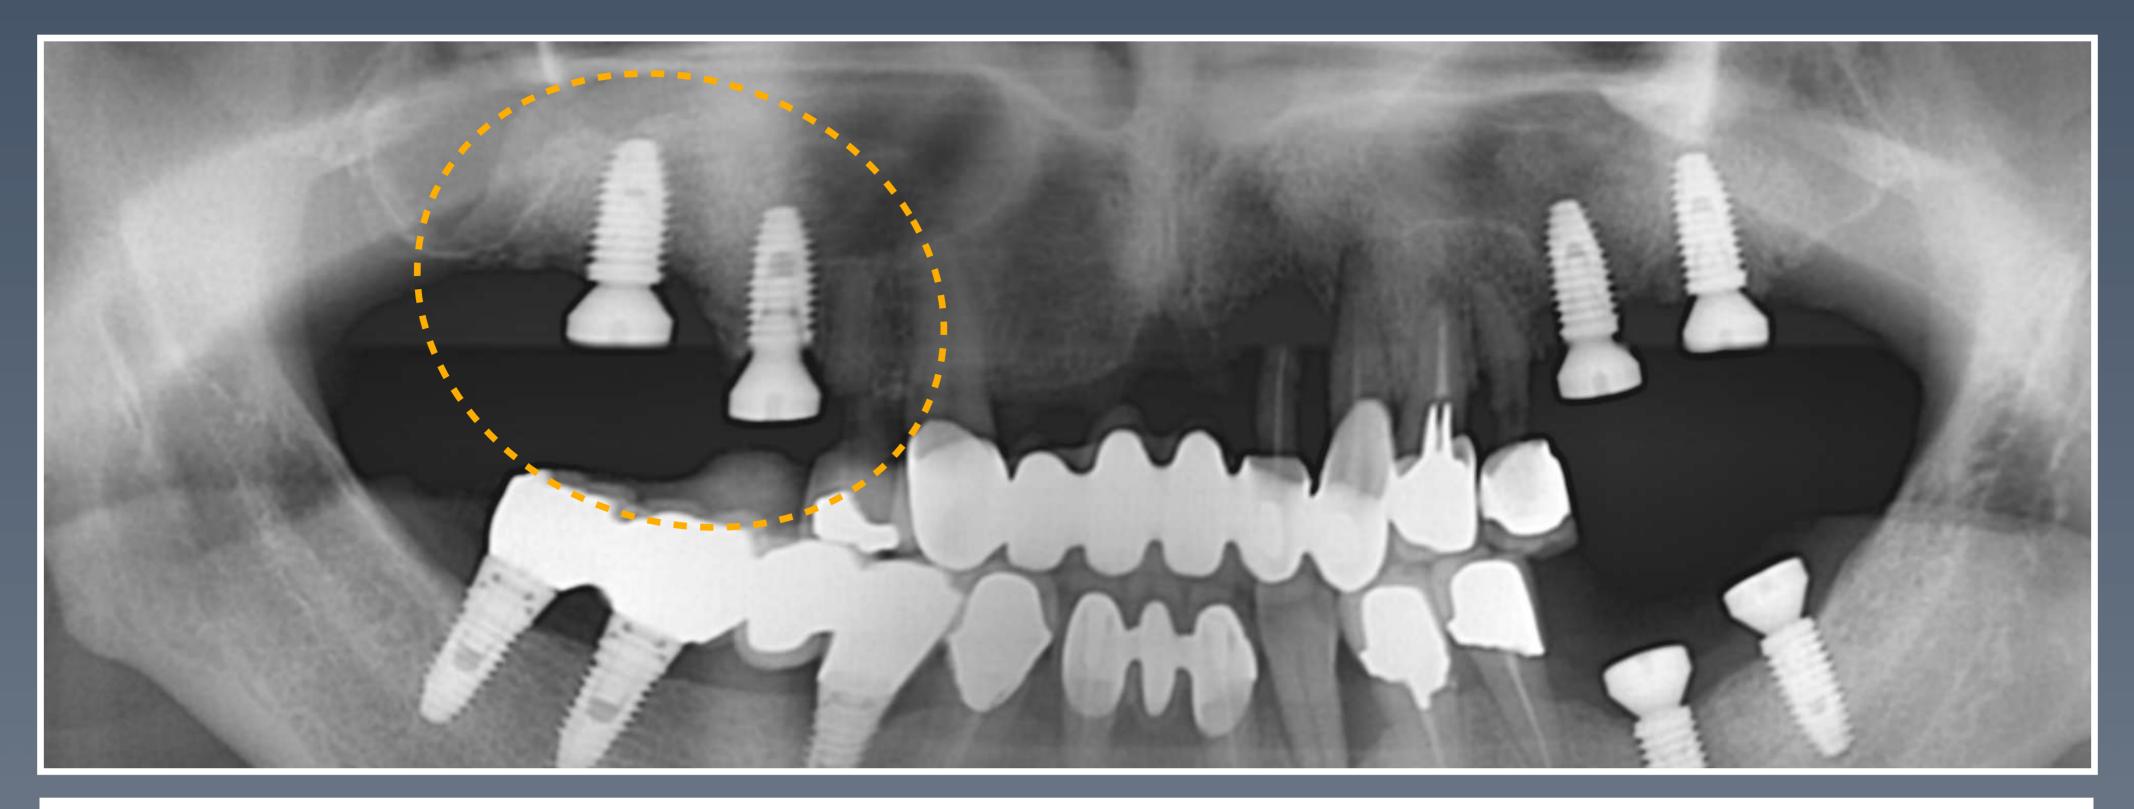
Panoramic radiograph after implant placement (Jul 20, 2012)

There is no significant bone loss or changes compared to the radiographs taken in 2012 and clinically prostheses was stable.
